From : Werner Botha
To : Pieter de Vries
Date : 04 July 2012
Subject : Adhesion Test Report
Product : Roofcryn painted on prepared and sealed asbestos panels

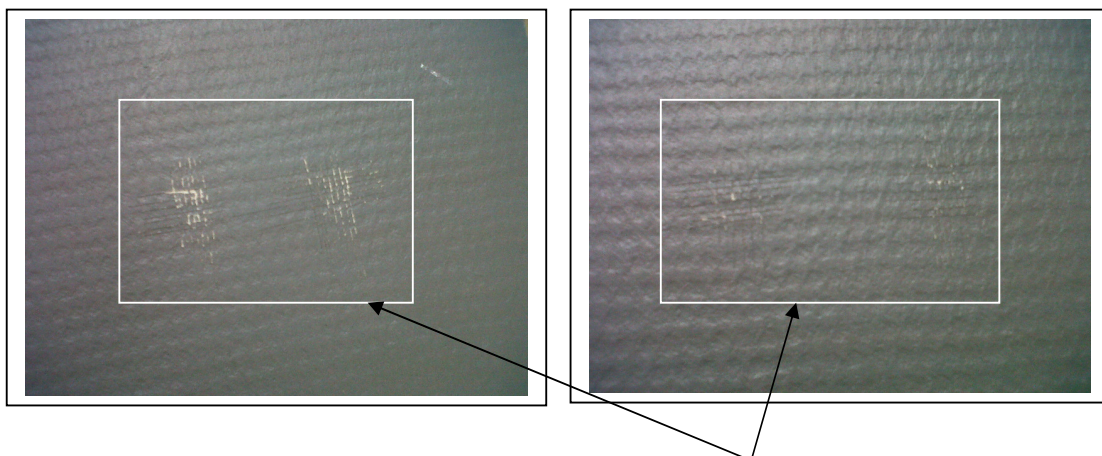
Test Area

Sample Panel A	Sample Panel B
Roofcryn	1 x Coat	2 x Coats
Percentage Film Loss	> 20 %	> 5%
Test Rating (1 Poor, 10 Excellent)	8	9.5
Olympus SZ 51 Observation	No loss of adhesion between paint and asbestos	No loss of adhesion between paint and asbestos

The pieces of paint film that was pulled off by the adhesion tape was analyzed under a Olympus SZ 51 magnifier and it was noted that there were no actual loss of adhesion between the paint and the actual asbestos which indicates that the percentage film loss was actually due to the

destruction of the asbestos surface rather than the loss of adhesion by the coating.

There where no significant loss of adhesion between Roofcyl and the customer supplied panels treated with the asbestos sealant. This indicates that Roofcyl is a suitable top coat for asbestos surfaces treated with the specific asbestos sealant of the client. There was however better results on the application of two coats of Roofcyl rather than one rendering the dried paint film to a thicker and more durable protective layer against weathering and other destructive elements.
