From : Werner Botha
To : Pieter de Vries
Date : 04 July 2012
Subject : Adhesion Test Report
Product : Roofcryn painted on prepared and sealed asbestos panels

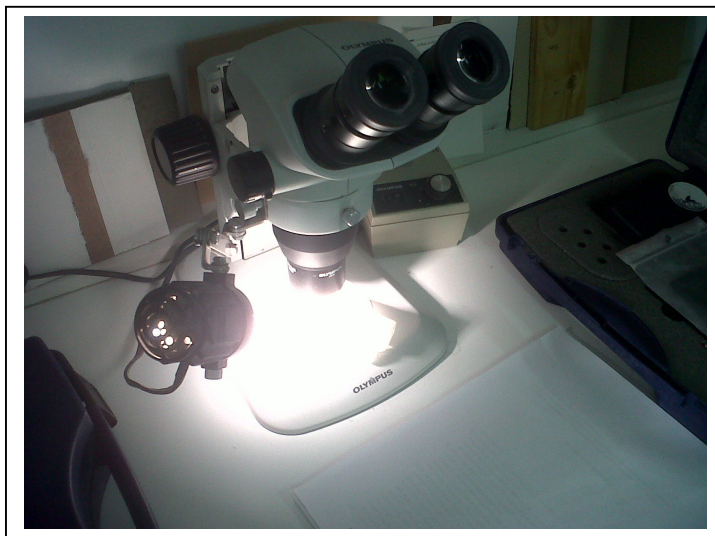
Olympus SZ51 Magnifier

The pieces of paint film that was pulled off by the adhesion tape was analyzed under a Olympus SZ 51 magnifier and it was noted that there were no actual loss of adhesion between the paint and the actual asbestos which indicates that the percentage film loss was actually due to the

destruction of the asbestos surface rather than the loss of adhesion by the coating.
